Radon Inspection Report

Measurement of Radon Concentration in Indoor Air

Report nr: 2700005145201904291046
Serial nr: 2700005145

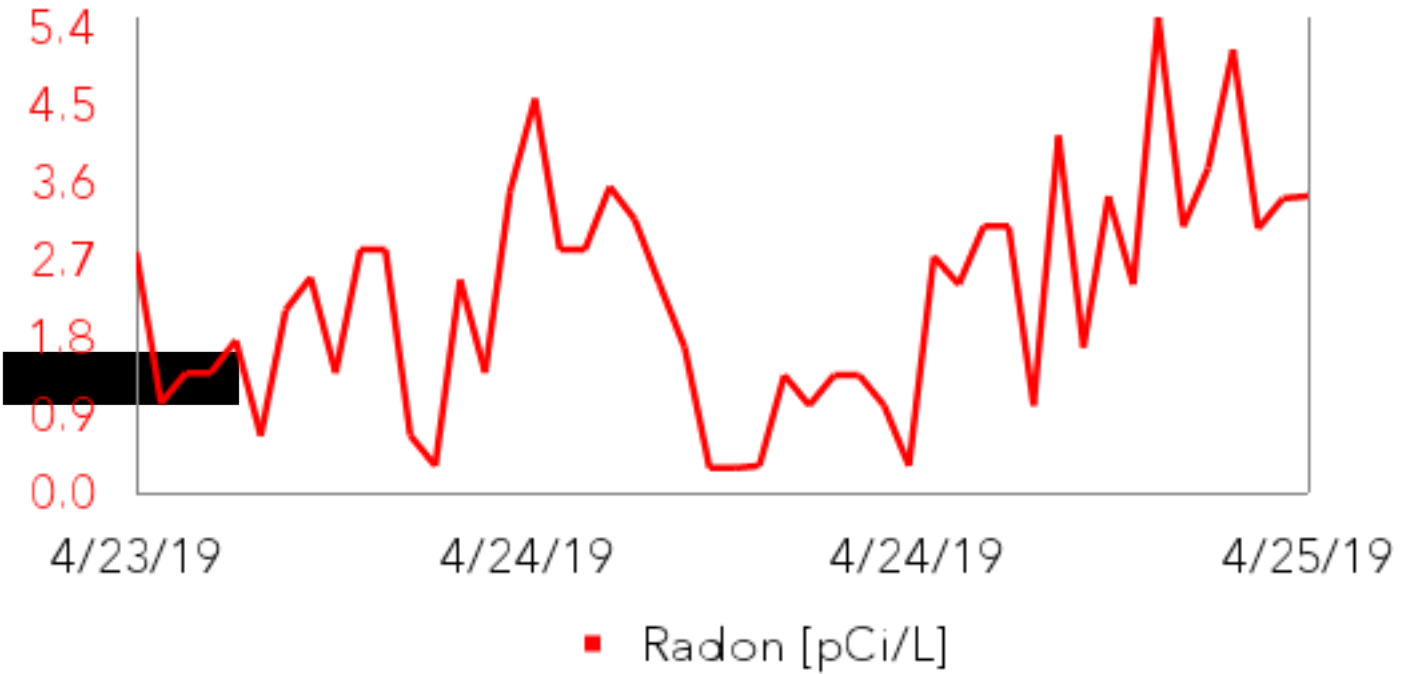
Radon Chart

Units	Min	Max	Average
Radon [pCi/L]	0.3	5.5	2.3
Temperature [°F]	69.8	76.6	73.5
Humidity [%rH]	34	43	39
Pressure [kPa]	97.69	98.55	98.14

Radon measurements for hour 1 to hour 48
